# Manhole Inspection Summary

Manhole # S13AA2004MH

**Location** Address: **5700 CROSS COUNTRY BLVD** Cross Street: **SULGRAVE AVE**

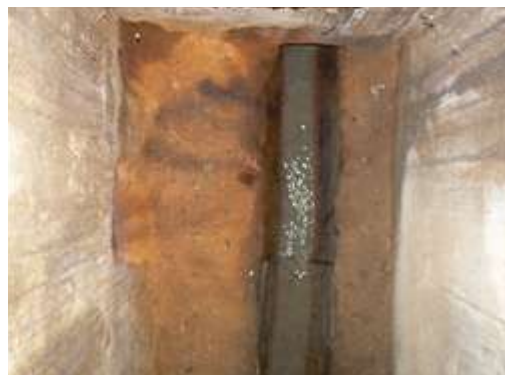
Top View

**Bench** ☒ Exists Material: **Concrete** ☐ Parged ☒ **Debris** (not Condition related)  
Condition: ☒ Sound ☐ Cracked ☐ Root Intrusion ☐ Deteriorated ☐ Leaks ☐ Debris

Bench debris.

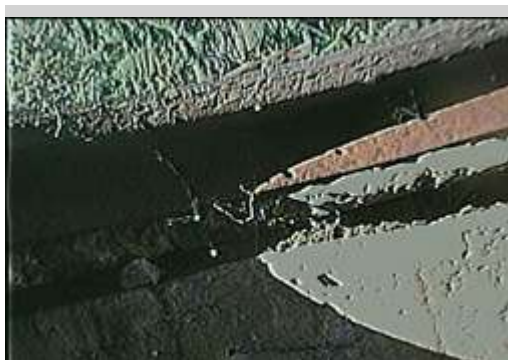
Defect

**Chimney / Frame Adjustment** ☒ Exists Material: **Brick and Concrete** ☐ Parged Height: **2** (in.)  
Condition: ☐ Sound ☐ Cracked ☐ Root Intrusion ☐ Loose Brick ☒ **Deteriorated**  
Infiltration: ☐ None ☒ **Joint** ☐ Cracks ☒ **Mortar** ☐ Roots ☐ Wall

Adjustment deterioration and infiltration.

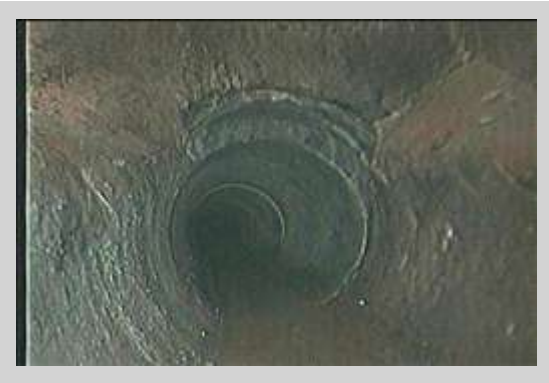
### 8 in. Circular Gravity Sewer Pipe Out @ 12 O'Clock

Infiltration: **Evidence** Pipe Seal Cond: **Cracked**

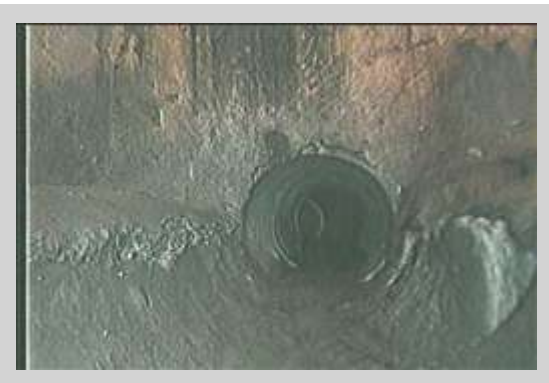
### 8 in. Circular Gravity Sewer Pipe In @ 6 O'Clock

Infiltration: **Evidence** Pipe Seal Cond: **Cracked**

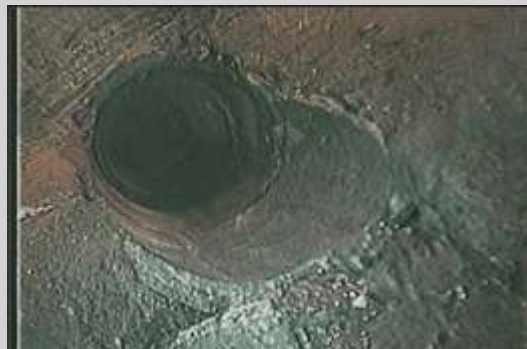
6 in. Circular Gravity Sewer

Infiltration: **Evidence**

Pipe Seal Cond: **Cracked**
